Study on the damage of bridges in 2008 Wenchuan Earthquake

2008 年中国汶川地震で被災した橋梁の被害と復興に関する研究

Keywords: Field damage investigation, damage of bridges, restoration, retrofit

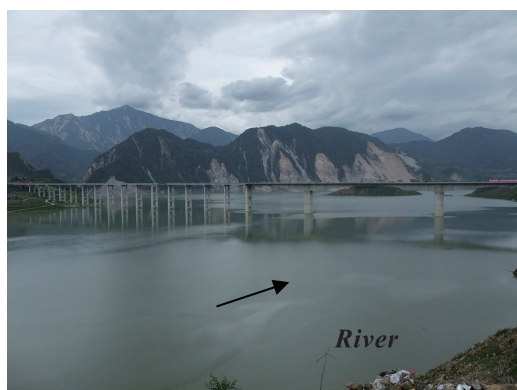
Photo 1 shows Miaozi Bridge. It is located where Duwen Highway (connecting Chengdu and Wenchuan) crosses the Zipingpu dam reservoir. The structure is 1,440 m long and consists of a three-span continuous PC-box type girder bridge with PC-T type girder approach bridges of two, four, and five spans. The main structure is a 450 m long (a main span of 220 m) three-span continuous pre-stressed concrete frame bridge. A PC-T type girder was constructed by connecting 50 m long, simply supported. The bridges were supported by elastomeric bearings. All spans were supported by nearly 100 m tall RC type piers. When the earthquake occurred, the bridges were almost completed, but expansion joints were not yet set. One of the two end-spans of a five-span continuous T-girder bridge collapsed as shown in Photo 2. It was reported that the distance between two adjacent piers which supported the fallen span was extended by about 0.69 m at the top based on measurements taken after the earthquake. Any damage in the piers above

Photo 1 Miaoziping Bridge

In the second investigation, the restoration of the fallen PC-T type girder span was completed. The restored girder was of the same type as that which was damaged. Moreover, the piers which suffered several small cracks were reinforced, with steel frames and concrete. After the earthquake, the fallen span was extended by about 0.7m from the original length. However we did not clear up the issue of displacement in this investigation. In the third investigation, the Duwen Highway was opened as shown in Photo 11.

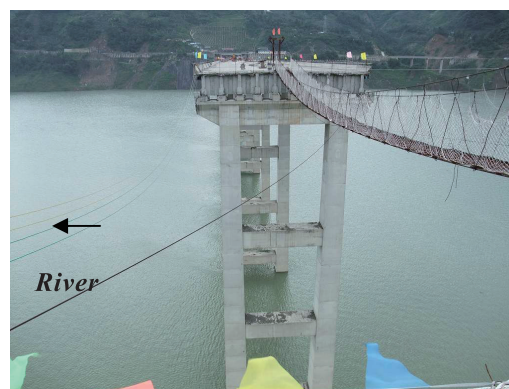
the water level was not identified; however, it was reported that piers suffered several small cracks at their base. It was likely that foundation flexibility further amplified the lateral displacement of the bridge. The fact that residual extension was nearly 0.69 m between the two piers implies that peak relative displacement between the two piers was possibly over a meter.

Photo 2 Span of falling PC-T type girder

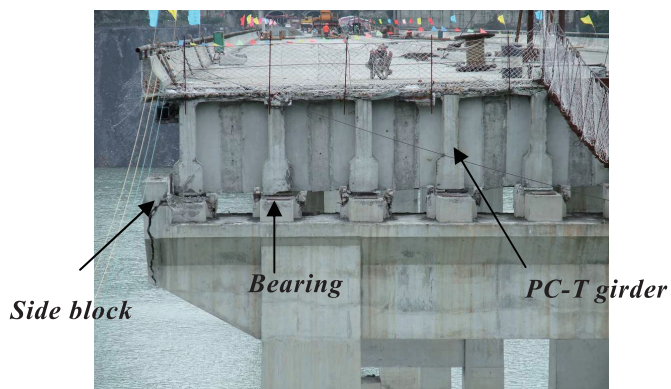
Photo 3 shows the damage of bearings at the fallen span. We see from the Photo 3 that the remaining part of the bearings and reinforced concrete side blocks were extensive damaged. Although reinforced concrete side blocks were installed at both sides of the deck, they could not fully restrict the deck displacement in the transverse direction. If unseating prevention devices were installed at this span, collapse could have possibly been prevented.

Photo 3 Damage of bearings and side walls

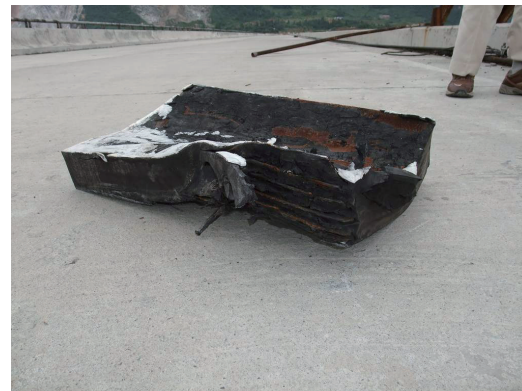
There were many other pieces of evidence that show that deck displacement was extremely large during the earthquake. Obviously failure of side blocks at both sides of the bridge allowed residual drift to develop in the transverse direction. Almost all side blocks suffered damage. Photo 4 shows one of the damaged elastomeric bearing. We see from Photo 4 that it was occurred extremely large displacement at the bearing. Vertical offset was also developed here because almost all elastomeric bearings moved out from their position due to the excessive relative bridge response displacement.

Photo 4 One of the damaged elastomeric bearing

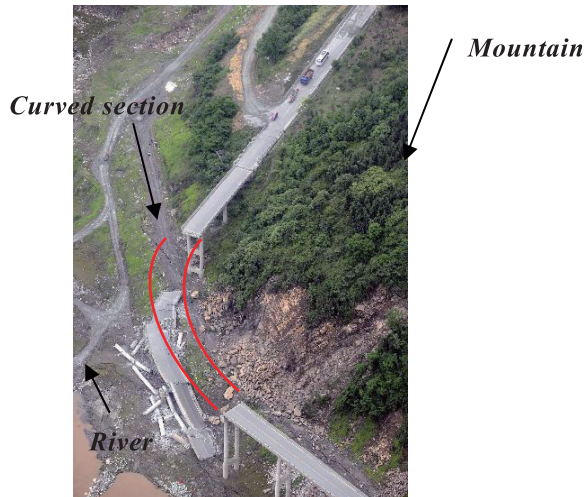
Baihua Bridge is located near main shock. It is about 500 m long PC type girder connecting Yingxiu and Dujianyang. It was completed in 2004. Photo 5 shows damage of Baihua Bridge. We can see from Photo 5 that it is located between a precipitous mountain and a river section. The four-span continuous curved section collapsed. By numbering the piers from P2 to P6, spans between P2 and P6 were supported by about 30 m tall moment-resisting frame piers consisting of two circular reinforced concrete columns and lateral beams. Other sections did not collapse but suffered extensive damage interrupting refuge and rescue, the remaining sections were removed by explosion as shown in Photo 6. Therefore, it was difficult to identify the section which collapsed during the earthquake; however, the collapsed section was preserved in its original condition after the earthquake.

Photo 5 Baihua Bridge (From SINA Corporation)

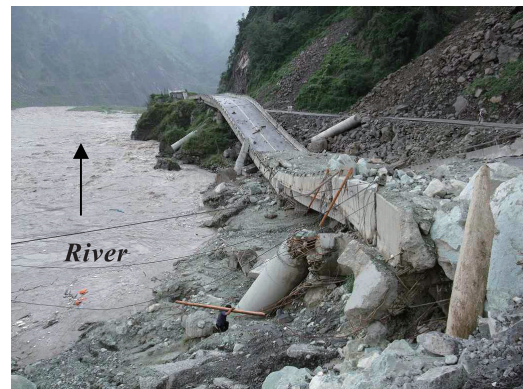
Photo 6 Exploded spans after earthquake

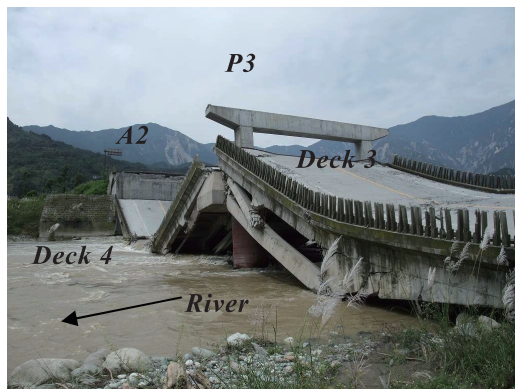
(a) Deck3-4

Photo 7 shows the damage of Xiaoyudong Bridge, and Photo 8 shows damage of slant-leg at Deck1. By numbering abutments, piers, and decks from the left bank, decks 1, 3 and 4 collapsed. And Deck3 and 4 was fallen. At right abutment A2, pavement permanently displaced about 0.2 m in the backsoil side due to the collision of deck 4 and A2. Extensive shear cracks were developed in the side walls resulting from

the collision. Most likely, deck 4 dislodged from A2 support due to excessive response displacement in the longitudinal direction, and then fell down, which resulted in the columns breaking. In the Deck2, flexural and shear failure developed at the slant-legs. These were a typical failure with limited plastic deformation capacity due to insufficient reinforcement. Reinforced concrete pile P2 suffered extensive cracks. This resulted from the extensive drift of P3 in the A2 side. This suggests that Deck 4 collapsed earlier than Deck 3. Once Deck 4 collapsed, the equilibrium of lateral forces between Decks 3 and 4 was lost, and P3 tilted extensively toward A2, which, in turn, resulted in Deck 3 being dislodged from its reliance on P3 and P4. As will be described later, this evaluation is consistent with a farmer's account that Deck 3 collapsed after Deck 4. Several surface fault displacements occurred around the bridge.

Photo 7 Damage of Xiaoyudong Bridge

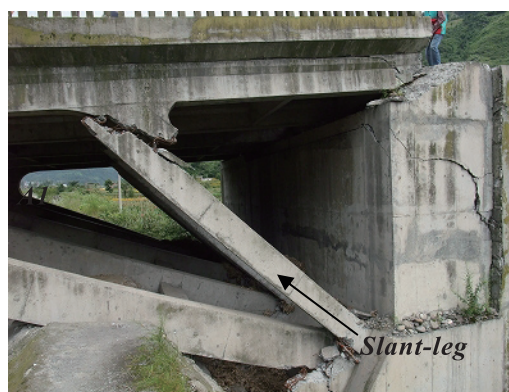
Photo 8 Damage of the slant-legs at Deck1

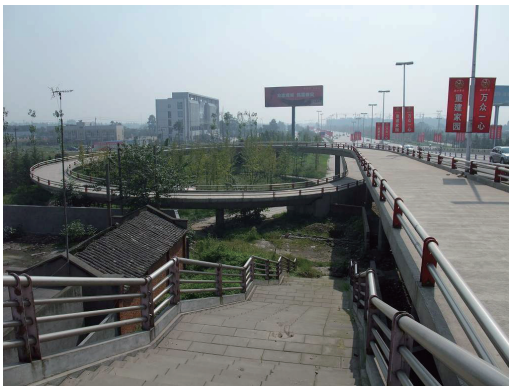
Huilan Bridge which is an interchange bridge is located in Mianyang. It is a railway crossing, consisting of a main bridge and four curved ramp bridges for light vehicles and passengers as shown in Photo 9. They

were 170-200 m long hollow deck girders with a plane curvature of 25.25m, and they were supported by 0.8 m diameter circular reinforced concrete piers. Girders were alternatively supported by rubber pad bearings and rigid connections. It was supposed that spans were too short to fully support the girders by rigid connections, and full support by rubber pad bearings would induce a large span displacement in the transverse direction because of the small radius of curvature.

Photo 9 Huilan Bridge

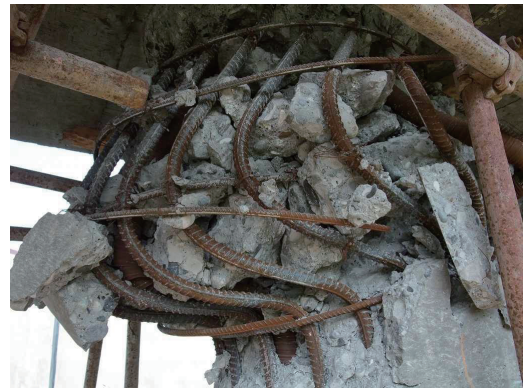
A ramp bridge suffered damage, and other ramp bridges suffered similar damage. Photos 10 show flexure and shear failure of piers which were rigidly connected to the girders. The failures resulted in settlement in the girders, and a number of extensive transverse cracks occurred at the bottom of deck panels near the support.

Photo 10 Typical damage of pier

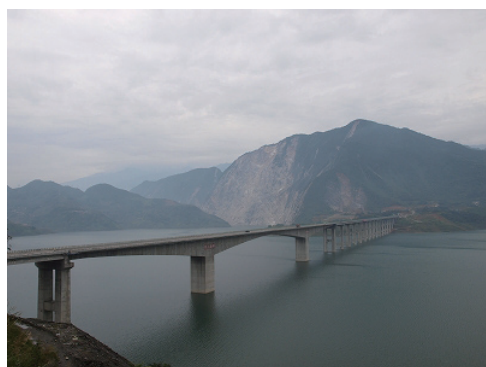
Photo 11 Miaozi Ping Bridge after restoration
(Third investigation)

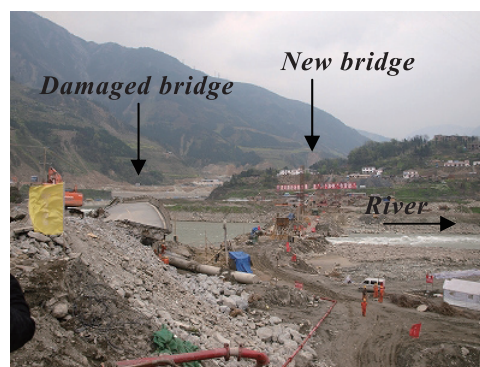
Photo 12 Baihua Bridge
(Second investigation)

In the second investigation, the road location and new bridge were moved downstream from their original location as shown in Photo 12. The substructure and foundation were constructed at the new

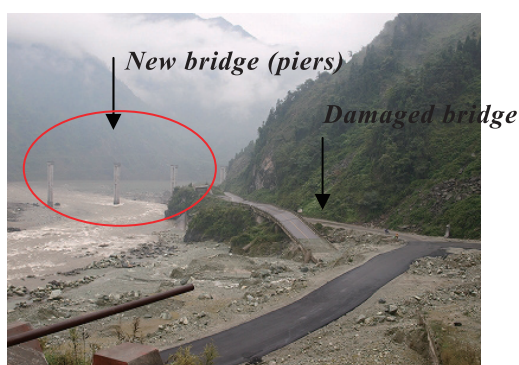
Photo 13 Baihua Bridge
(Third investigation)

location. In the third investigation, the construction of the new bridge's substructure was finished as shown in Photo 13. The PC girder was made on the left bank, and the girders were erected using an erection girder from the left bank. The new bridge was a different type and used PC-T type girders, simply supported

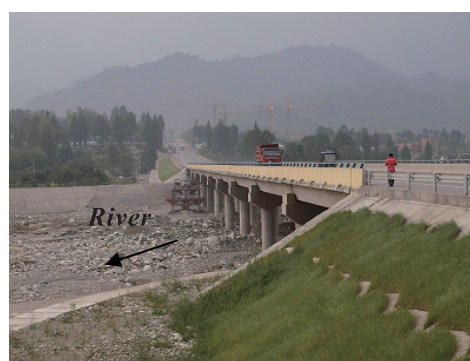
Photo 14 Xiaoyudong Bridge
(Third investigation)

In the second investigation, we surveyed the pre-earthquake characteristics of the bridge to determine the cause of damage. The restoration of this bridge was conducted upstream from the original site. In the third investigation, we again measured the same characteristics, as well as surveying for additional information. The new bridge and road were opened as shown in Photo 14. The bridge used simply supported PC-T girders and was supported by elastomeric bearings.
