Study on the damage of bridges in 2008 Wenchuan Earthquake

2008 年中国汶川地震で被災した橋梁の被害と復興に関する研究

Keywords: Field damage investigation, damage of bridges, restoration, retrofit

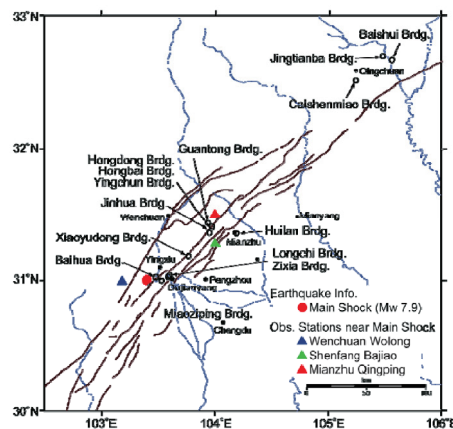
Fig.1 Relationship between faults and bridges

Fig.1 shows relationship between faults and typical damage of bridges. The Wenchuan earthquake was induced by rupture of the Longmen Shan Fault. Large scale thrusting of the Tibetan Plateau towards the east of the rigid block of Sichuan Basin resulted in the NE-SE dip-slip reverse fault [Densmore et al, 2008; Lekkas, 2008]. The fault zone extended from Yingxiu Town, Wenchuan County, to Mianzhu City, Beichuan County, and to Qingchuan County. The epicenter was located at Yingxiu Town. Extensive damage occurred in nearly 300 km long and 50 km wide regions along the fault [Li and Zhao, 2008]. There were precipitous mountainous regions with steep streams. Consequently, shallow and deep slope failures occurred extensively. The damaged regions had very harsh natural conditions.
